CHEMICAL PLANT OPERABLE UNIT REMEDIAL ACTION REPORT

WELDON SPRING SITE REMEDIAL ACTION PROJECT
WELDON SPRING, MISSOURI

JANUARY 2004

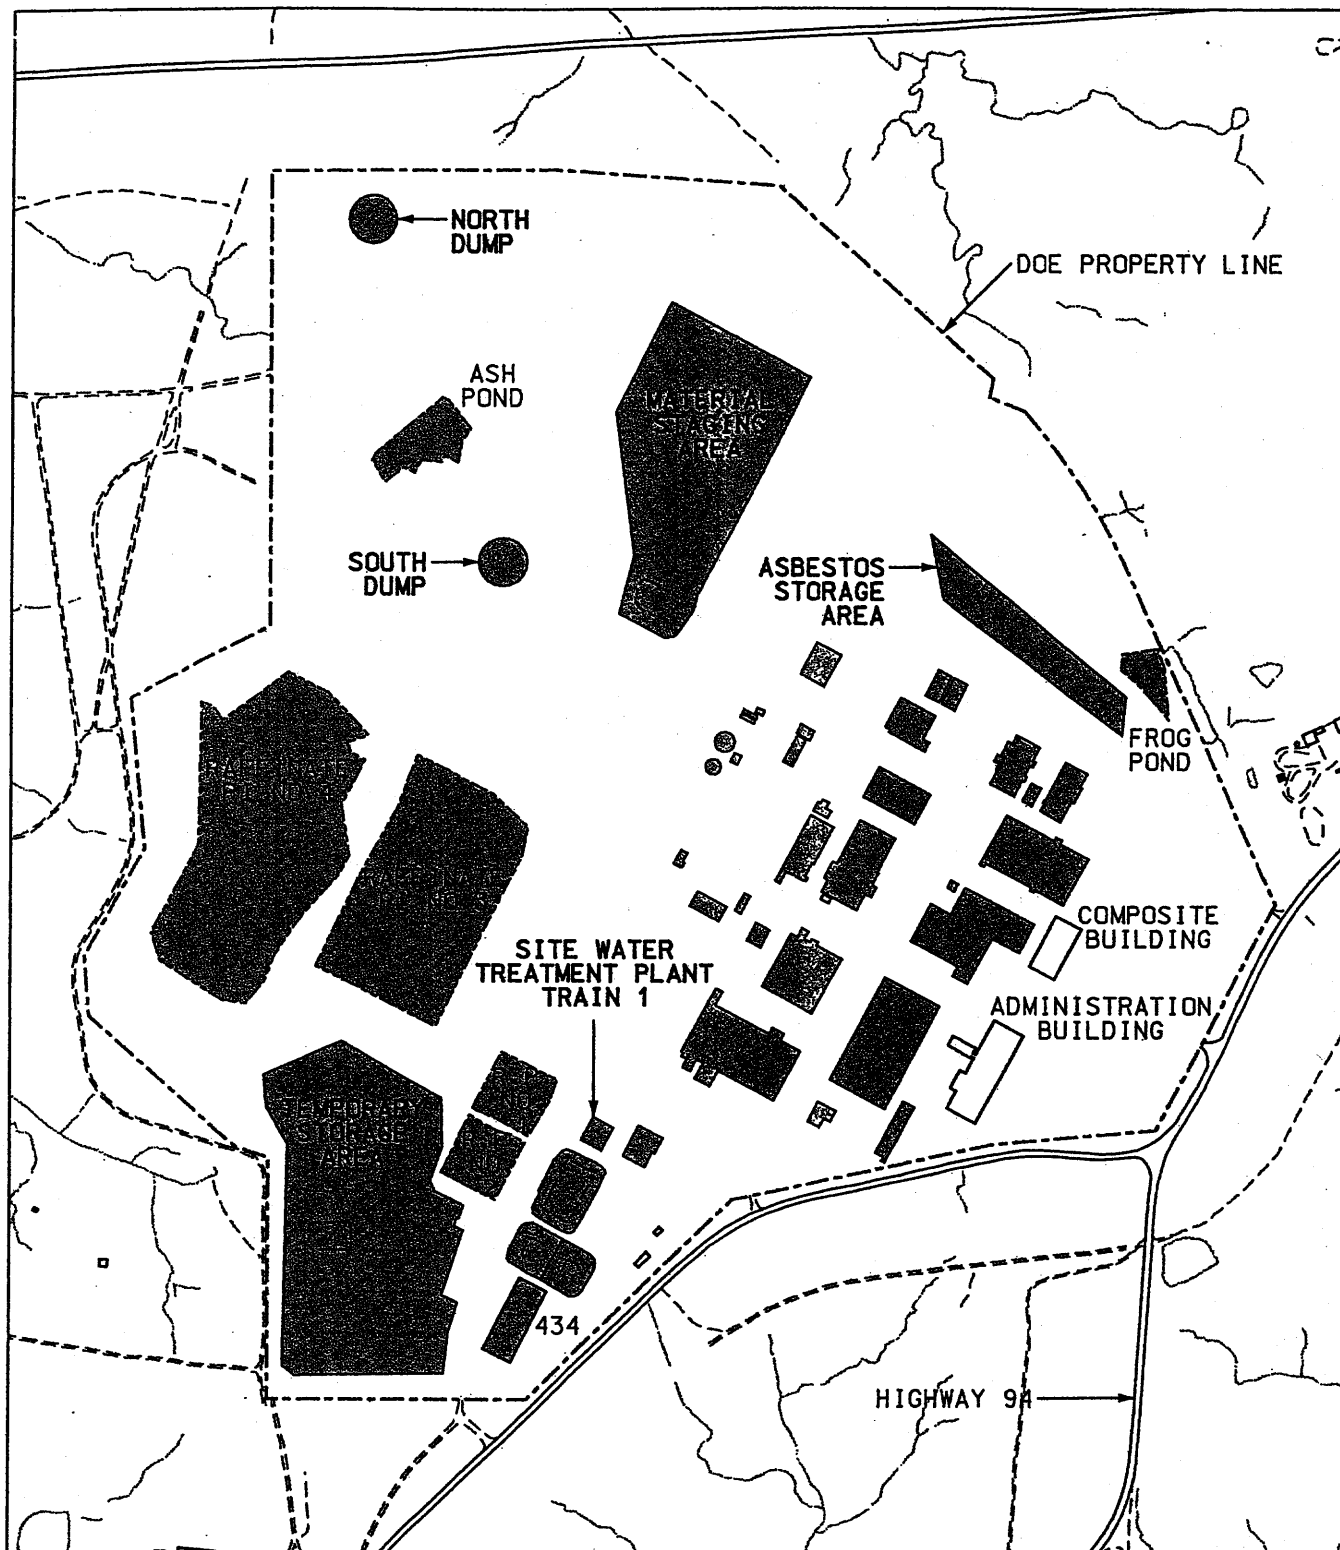
FIGURE 1-4

Figure 1-4 shows the areas of contamination at the chemical plant site including building foundations, and interim storage areas. The Frog Pond received precipitation runoff from the northeast corner of the chemical plant and from the plant storm sewer system.

CONTAMINATED AREAS 1994

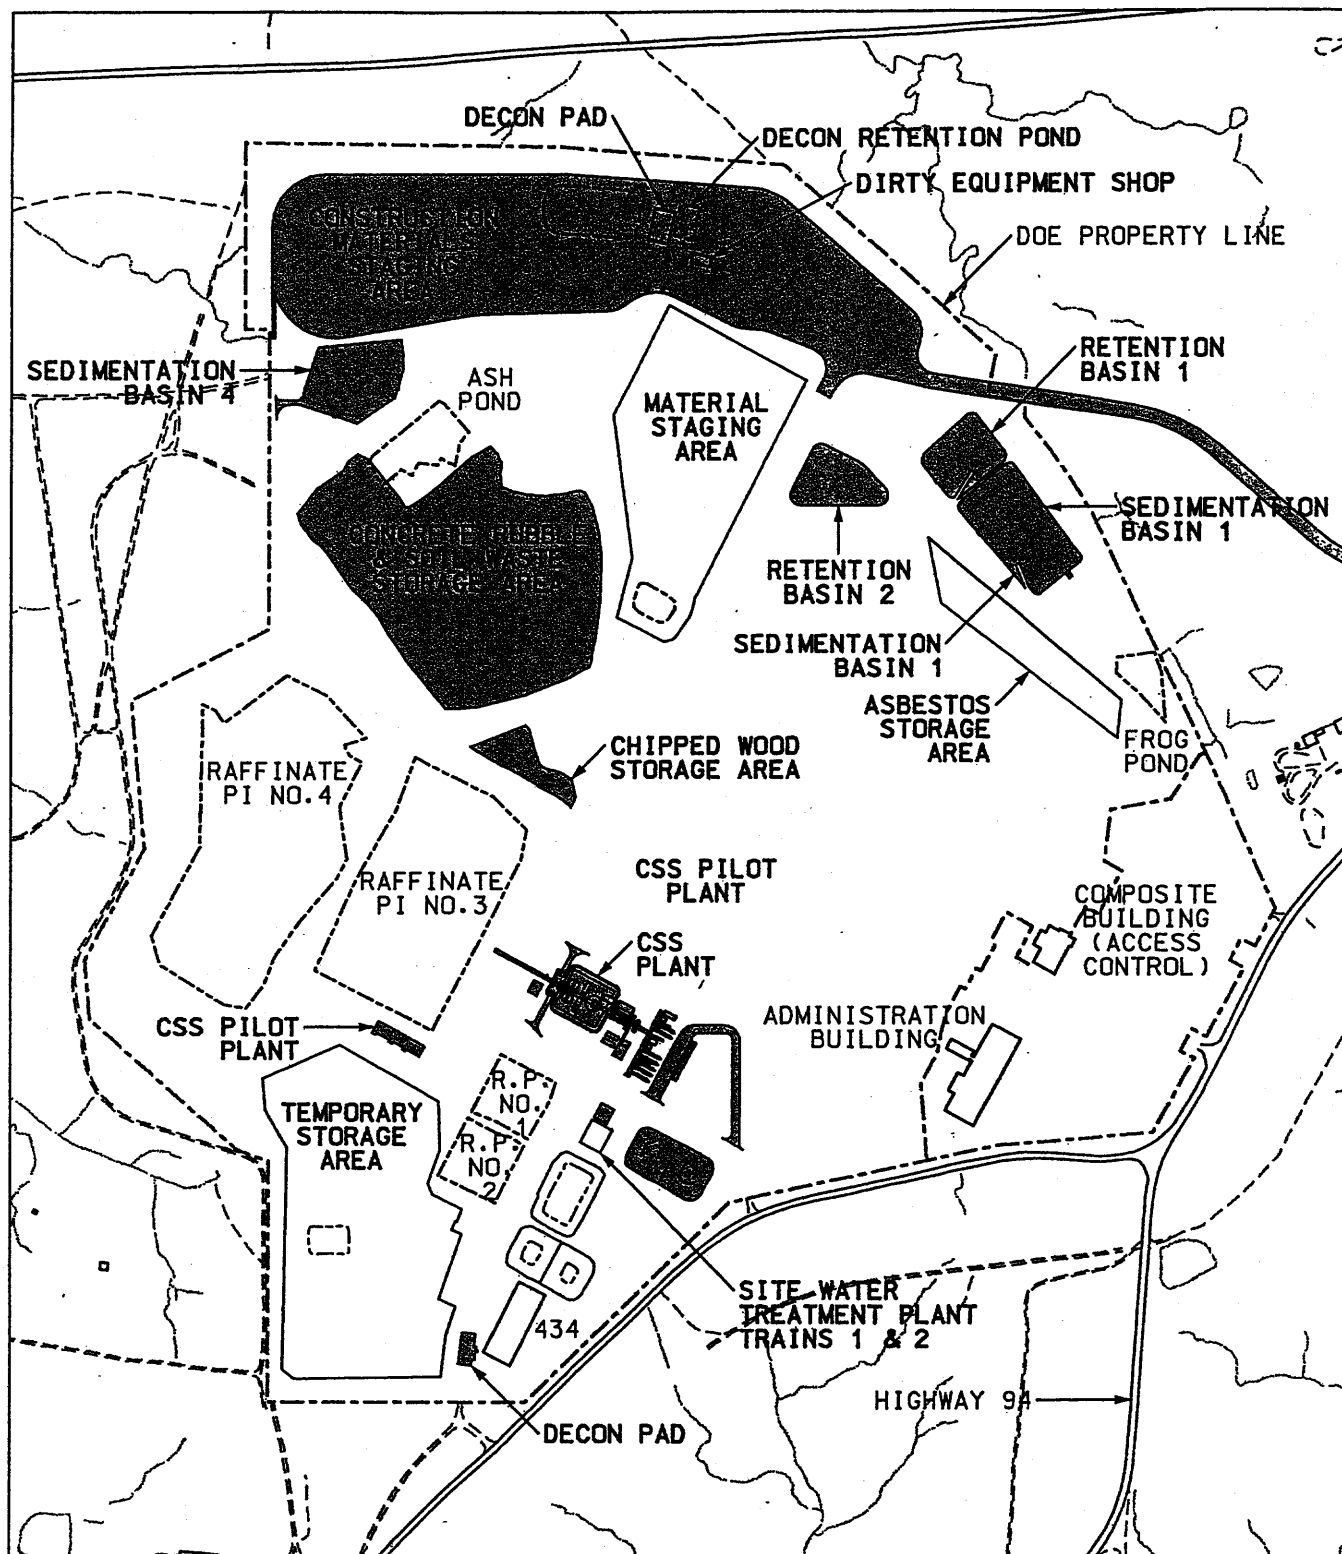
FIGURE 3-1

SITE PREPARATION AND TREATMENT FACILITIES

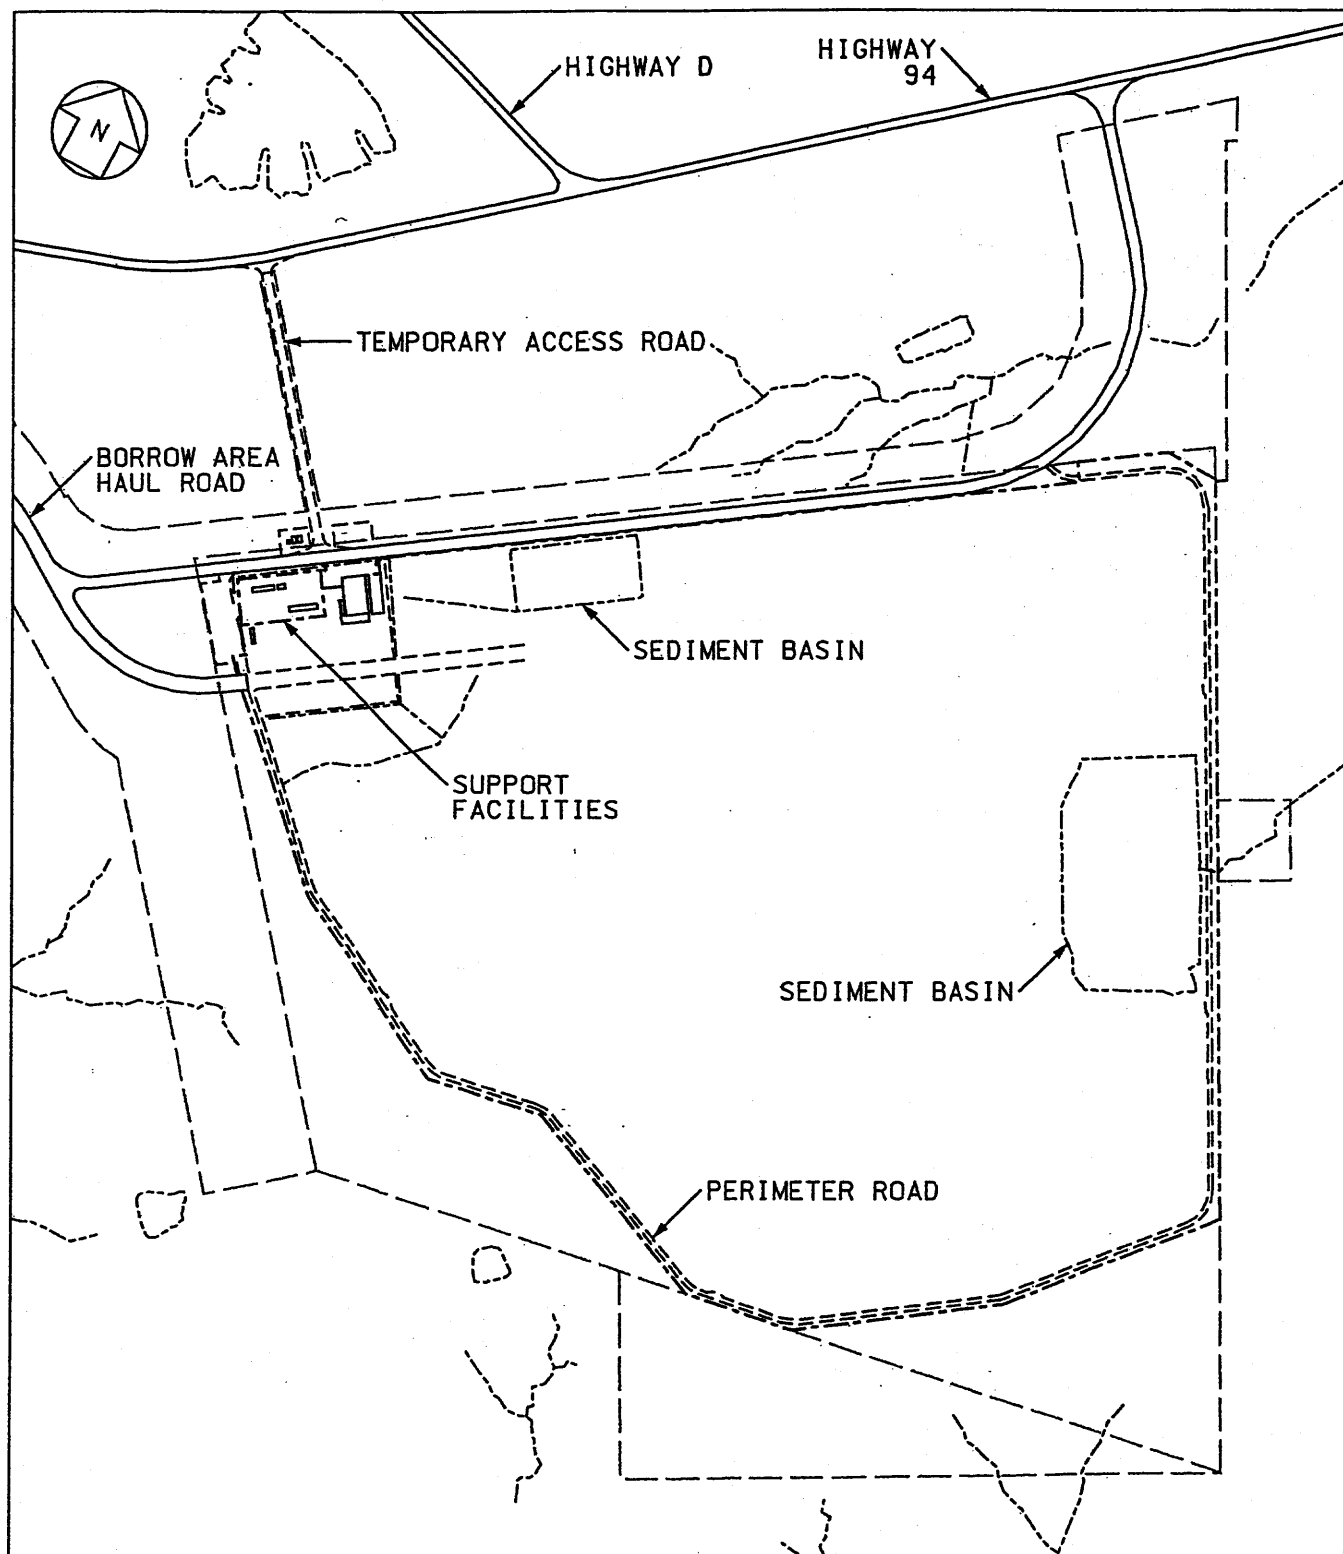
FIGURE 3-3

The borrow area was located roughly 1 mile northeast (NE) of the Chemical Plant Site on property leased by the Missouri Department of Conservation (MDC) in their Weldon Spring Conservation Area. The agreement with the MDC allowed for excavation of up to 2 million cu yd of soil for use in backfills and construction of the disposal facility. Early studies proved the low permeability of the soil for its use in the foundation, bottom liner, clean fill dikes and cover of the cell. Construction began in July of 1995 and was completed in December, 1995 costing a total of \$1.7 million. The development of the borrow area included the construction of facilities and connection of utilities. Shown in Figure 3-3.

BORROW AREA FACILITIES

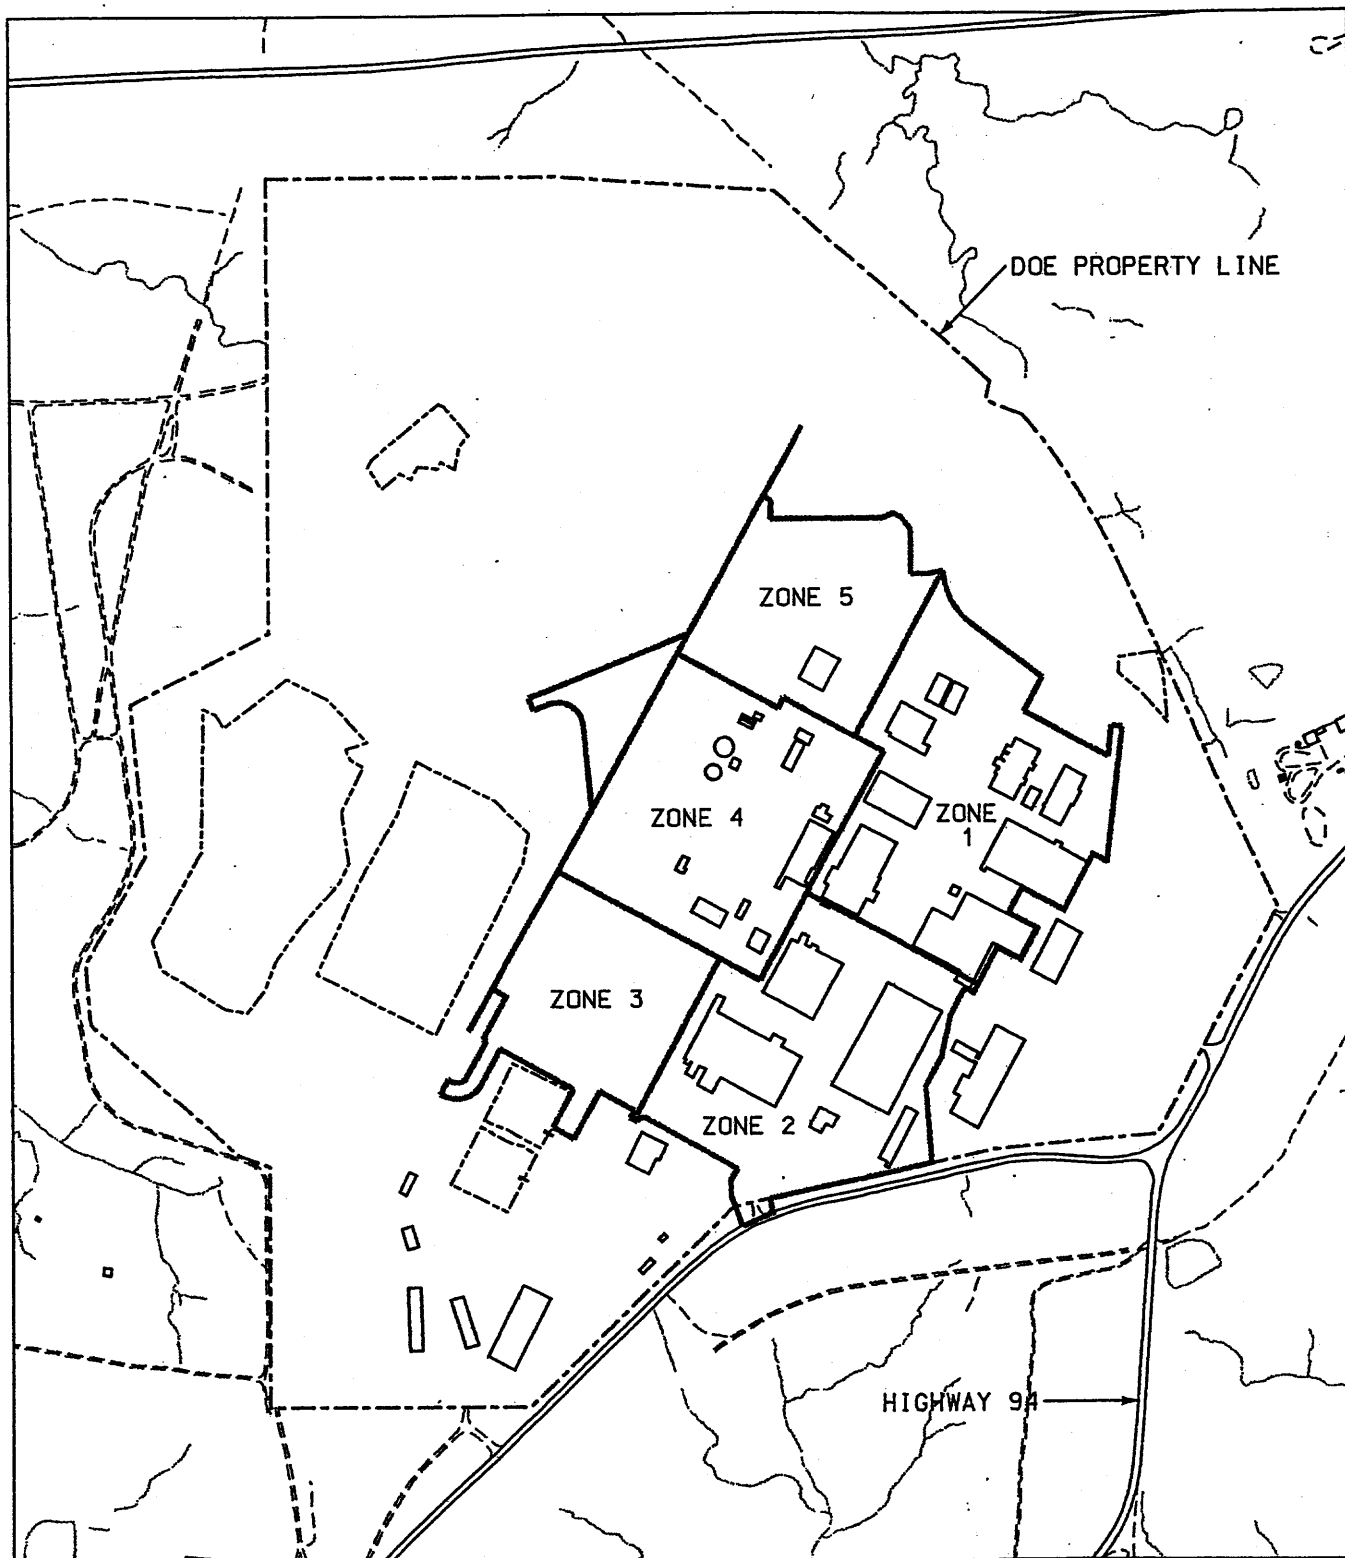
FIGURE 3-5

Remediation activities in the footprint of the cell and construction of the low permeability foundation beneath the cell were performed under WP 420. The removal of foundations of the 44 Chemical Plant buildings, equipment pits/sumps, underground piping between the buildings and excavation of contaminated materials began in early 1996. Work was completed in July, 1997 with a total cost of \$19.6 million. The area of remediation was broken into the work zones shown in Figure 3-5. Activities included:

WP420 WORK ZONES

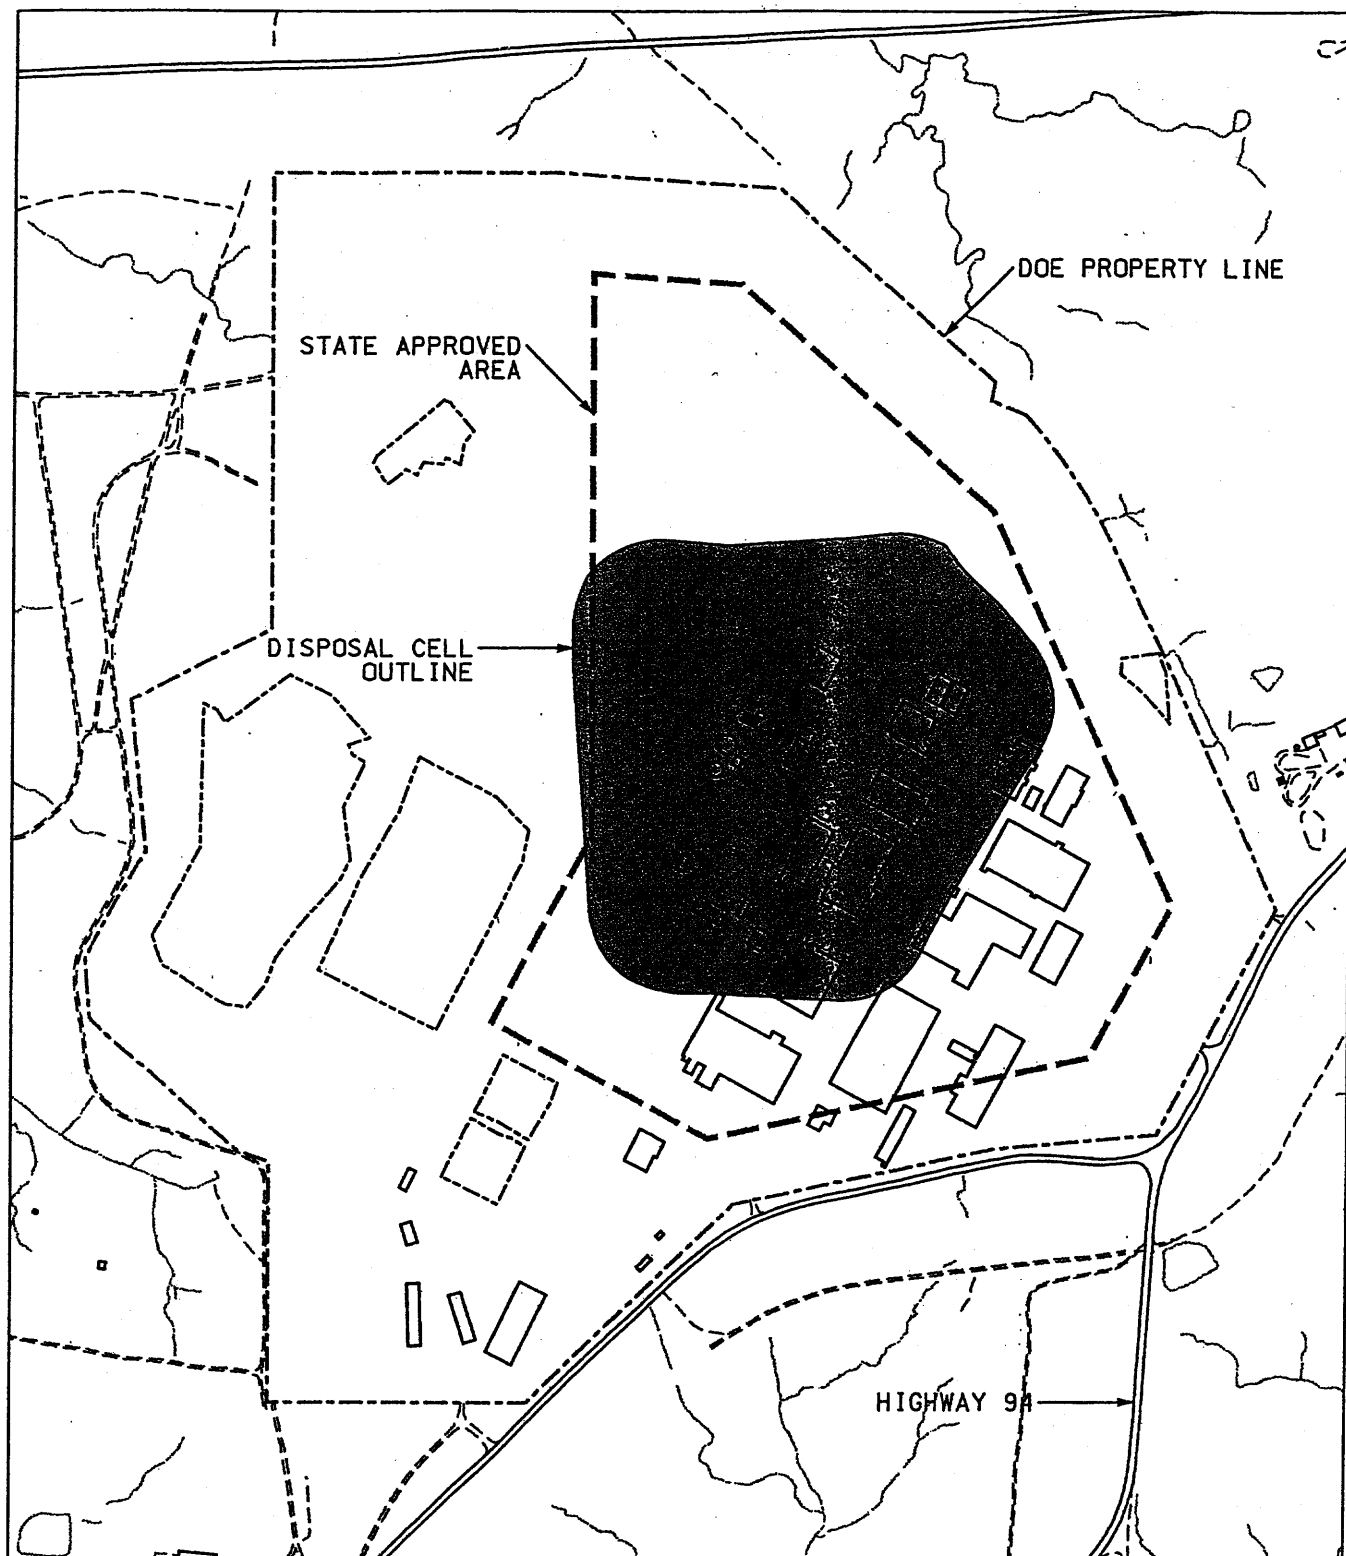
FIGURE 3-12

The cell maximum height is 91 feet, as measured between the toe apron elevation near the east discharge outlet and the highest point of the cover. Average height of the cell is 75 feet. The waste column has a maximum thickness of 63 feet, measured between the highest waste elevation and the LCRS elevation along the same vertical.

DISPOSAL CELL LOCATION VERSUS
SITE SUITABILITY AREA

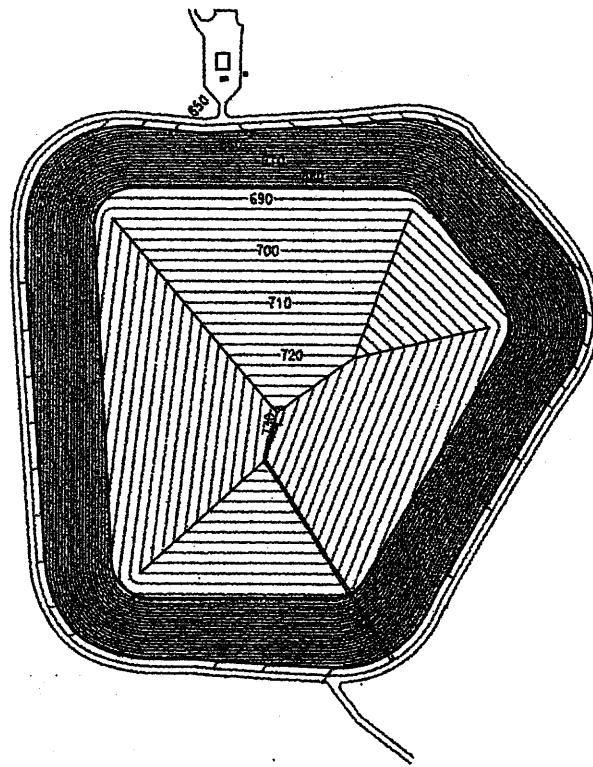
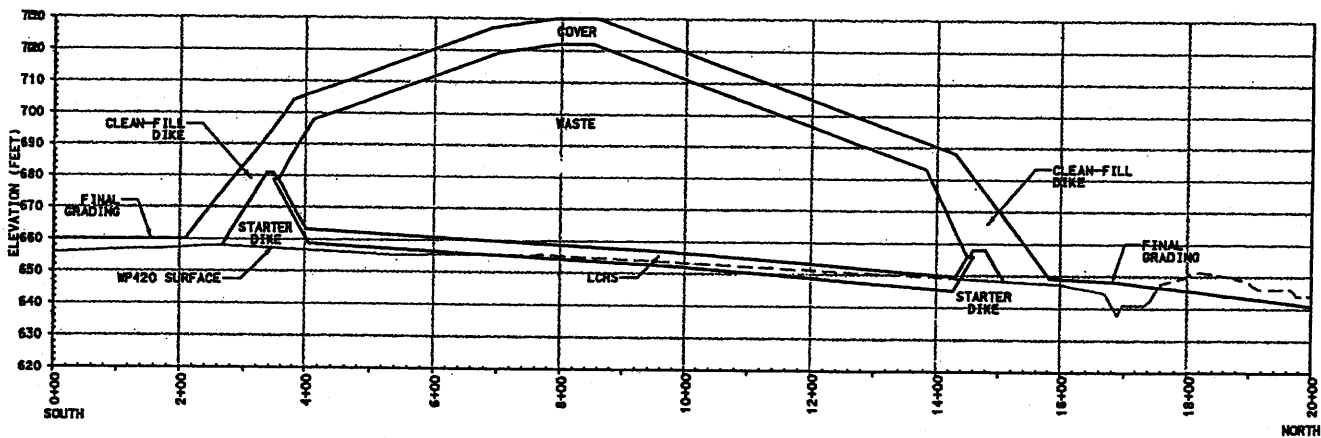
Figure 3-13 is a cross-sectional view of the disposal cell.

FINAL LAYOUT AND CROSS-SECTION

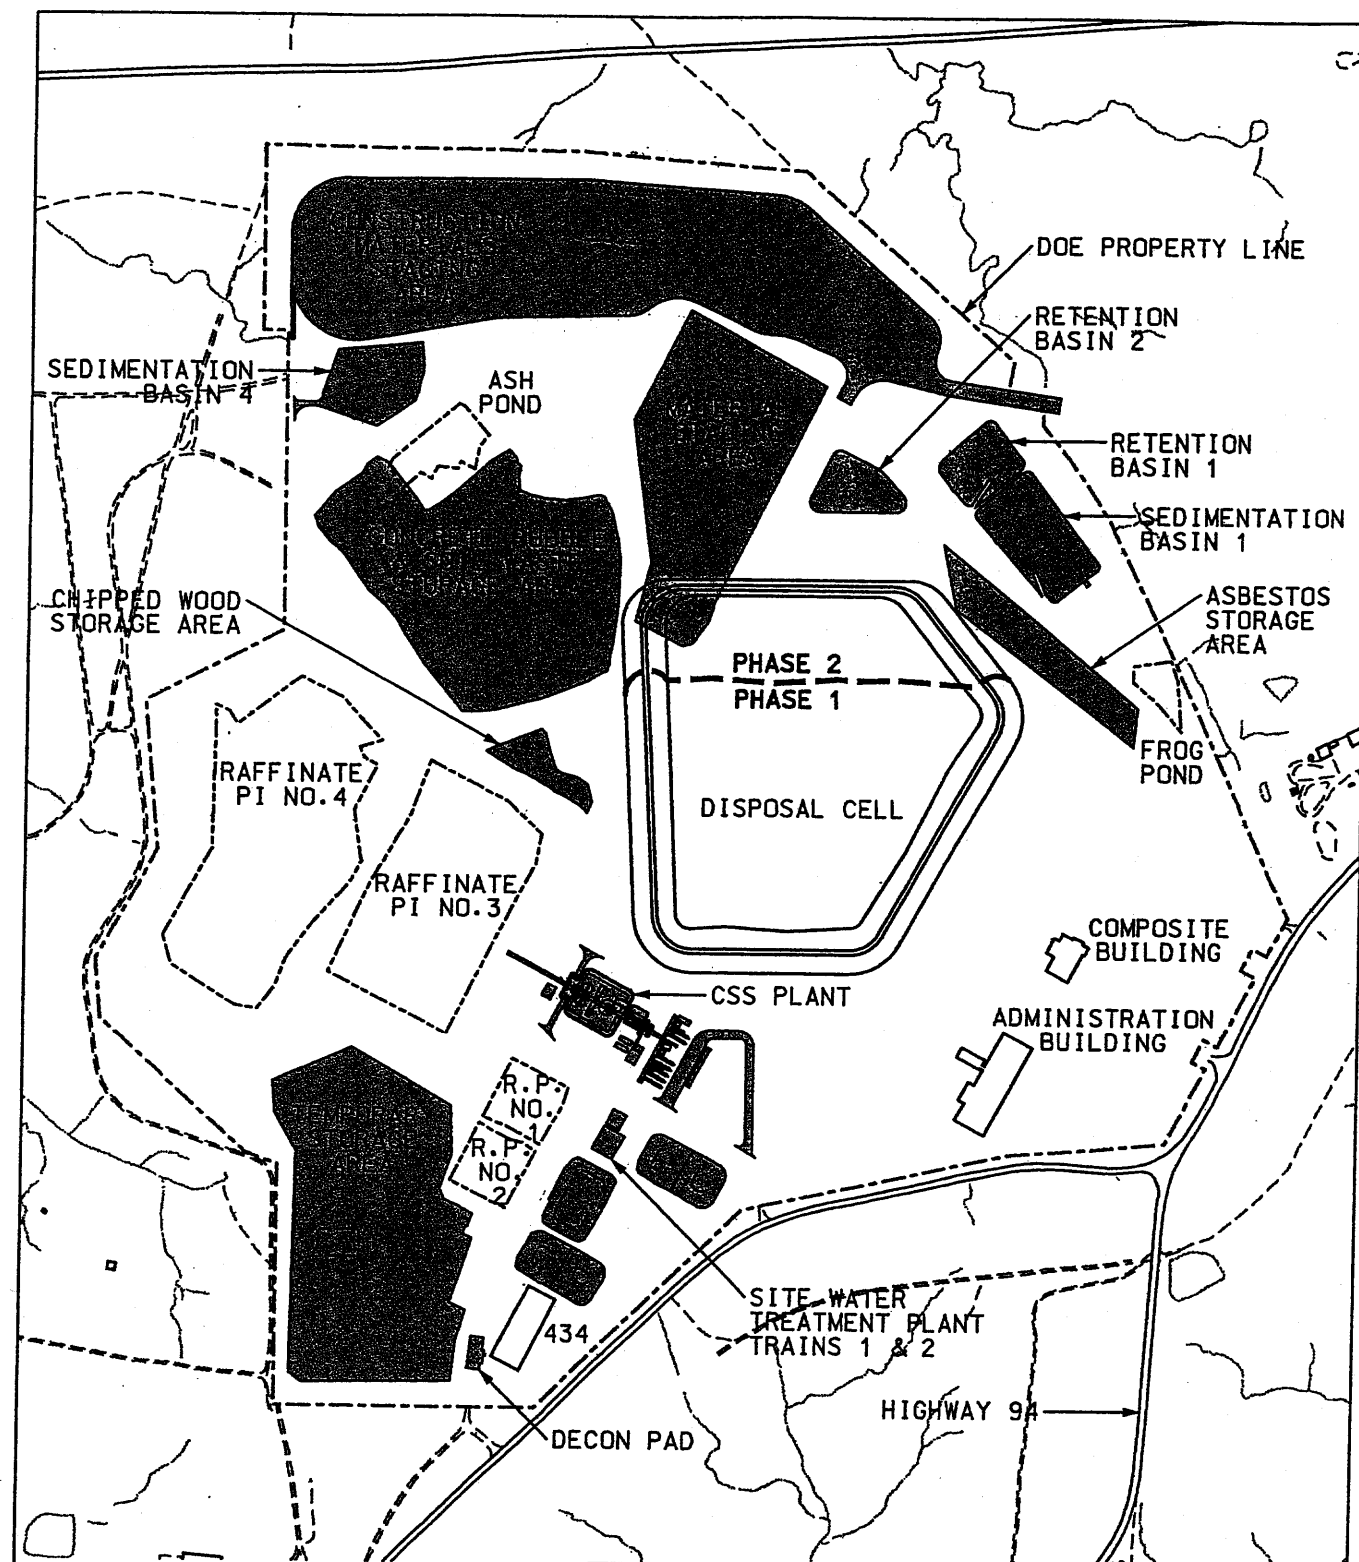
FIGURE 3-14

As described in Section 3.1.5, the foundation of the disposal cell was constructed by the WP 420 subcontract. The building foundations were removed and backfilled with low permeability clay from the borrow area. Backfilling and additional grading was completed to the bottom elevation of the cell's compacted clay liner. Then, a protective 18" layer of common fill was placed to protect the clay i.e. prevent desiccation. Unsuitable soils beneath the cell footprint were also removed and replaced with low permeability clay. Continuation of the low permeability subgrade to the north was implemented so that potential expansion could be accommodated if waste volumes exceeded the original planned capacity. Appendix G, Sections 1.1 – 1.6 provides the details of this construction effort and the quality control which assured an adequate compaction effort.

DISPOSAL CELL CONSTRUCTION PHASE 1 AND 2 STARTER DIKES

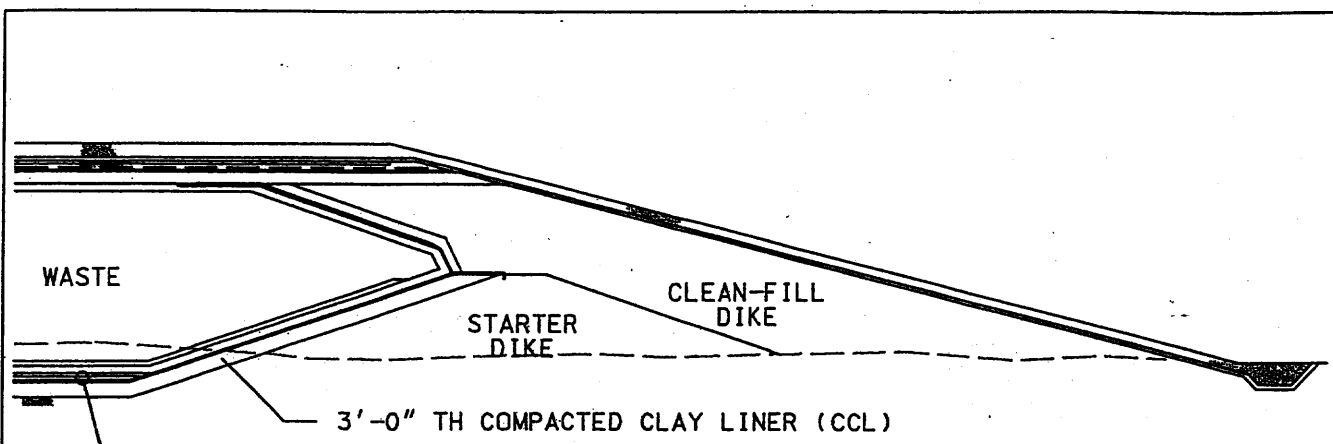
BOTTOM LCRS

- 1'-6" TH SELECT SOIL WASTE
 - 8" TH FILTER SAND
 - 8" TH DRAIN GRAVEL (PRIMARY LCRS W/ 4" DIA HDPE SMOOTH PERF PIPES)
 - 160-MIL GEOTEXTILE
 - 80-MIL TEXTURED HDPE GEOMEMBRANE
 - 120-MIL GEOTEXTILE
 - 250-MIL GEONET (REDUNDANT LCRS)
 - 120-MIL GEOTEXTILE
 - 80-MIL TEXTURED HDPE GEOMEMBRANE
 - BENTONITE MATTING
 - 3'-0" TH COMPACTED CLAY LINER (CCL)
-] TYPE 3 GCL

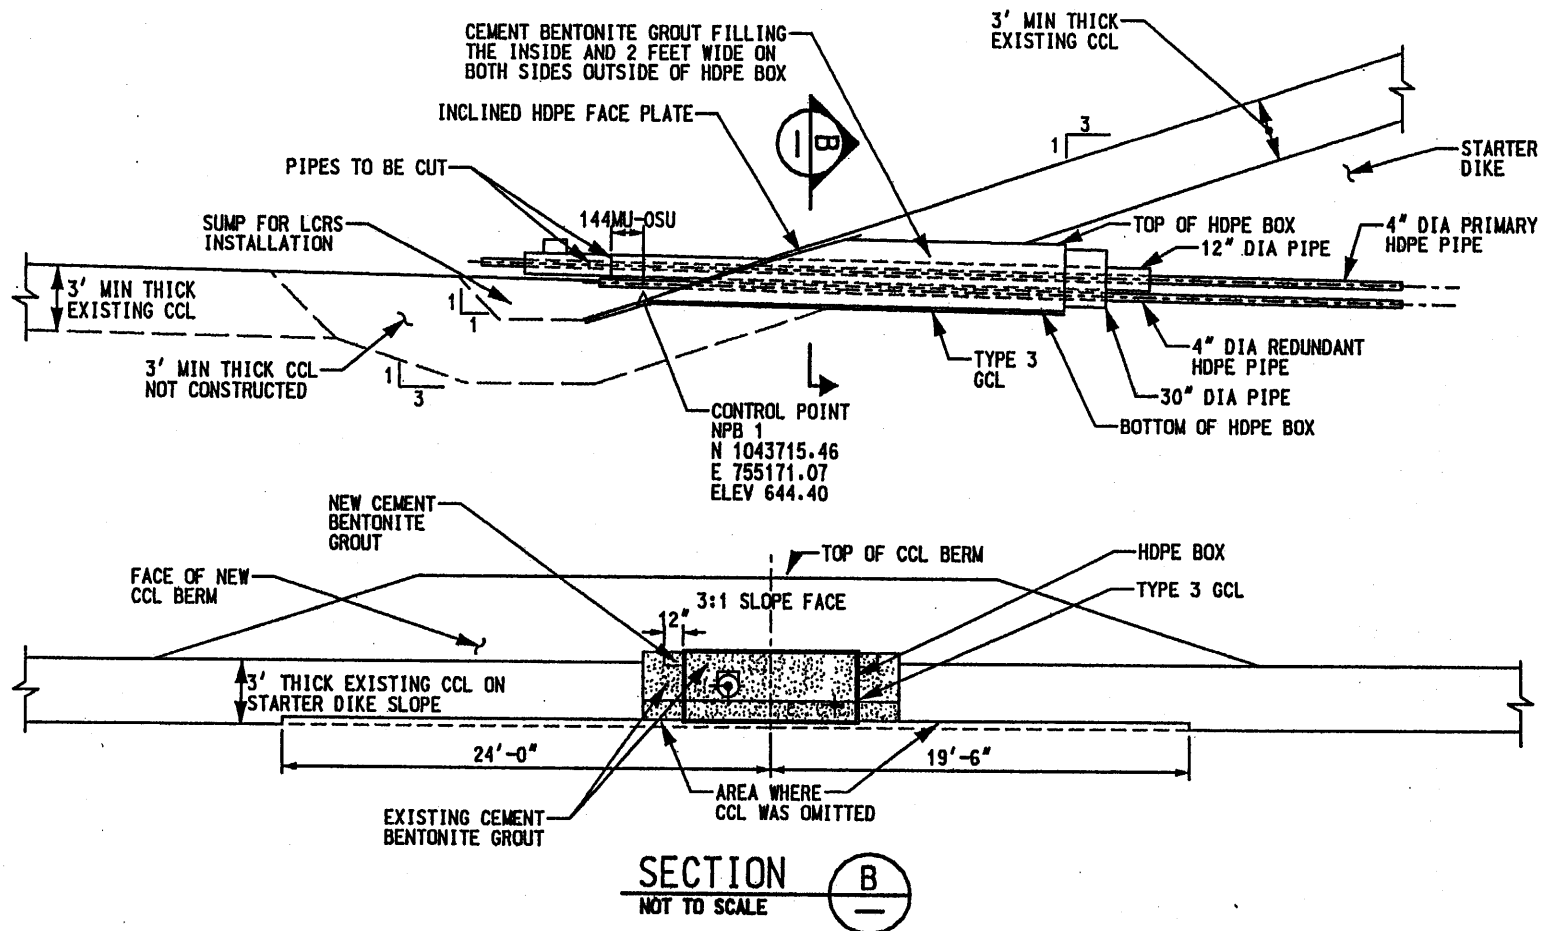
FIGURE 3-17

The disposal cell leachate collection sump serves a double function: as a storage reservoir for leachate and as a measuring device for flow rates. The LCRS sump is a 15-foot tall, 60-inch diameter HDPE structure manufactured by ISCO Industries of Louisville, KY. ISCO also manufactured the 200-foot long, 42-inch diameter HDPE Leachate Retention Pipe. It has a calculated capacity of 12,600 gallons, corresponding to a design estimated leachate volume generated in one month. WP 505V subcontractor performed the earthwork excavations necessary for extension of the primary and secondary leachate pipes from the cell and installation of the collection pipe, sump and manhole. The geosynthetic specialty subcontractor, Manhattan Environmental, installed the pipes and the secondary collection system of liners (the burrito)

LCRS DIKE PENETRATIONS

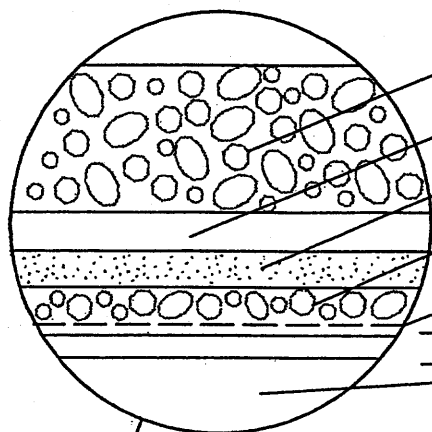
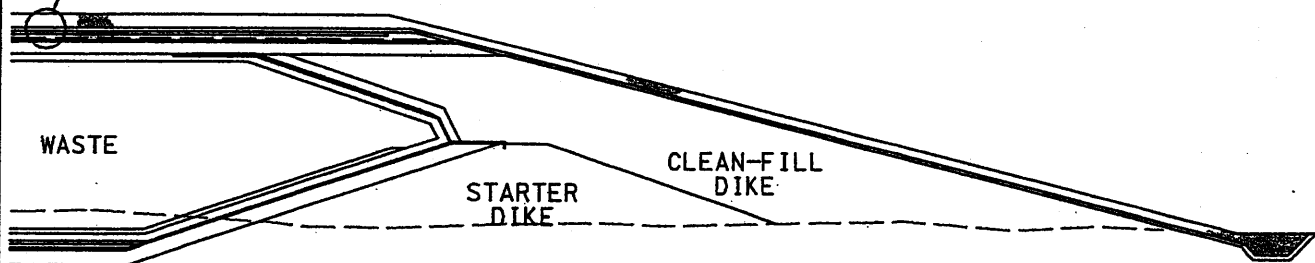
FIGURE 3-22

Construction of the first foot of the barrier was executed in a 12-inch loose lift, compacted with 10 passes of a tamping foot roller, density requirements being waived. Once construction operations resumed, this protective first layer was trimmed to 10-inches and the upper half processed in place for clod size reduction.

3'-6" TH RIPRAP (EROSION & BIOINTRUSION BARRIER)

8" TH BEDDING

3'-0" TH INFILTRATION (LOW PERMEABILITY CLAY) & RADON BARRIER

FINAL COVER LAYOUT

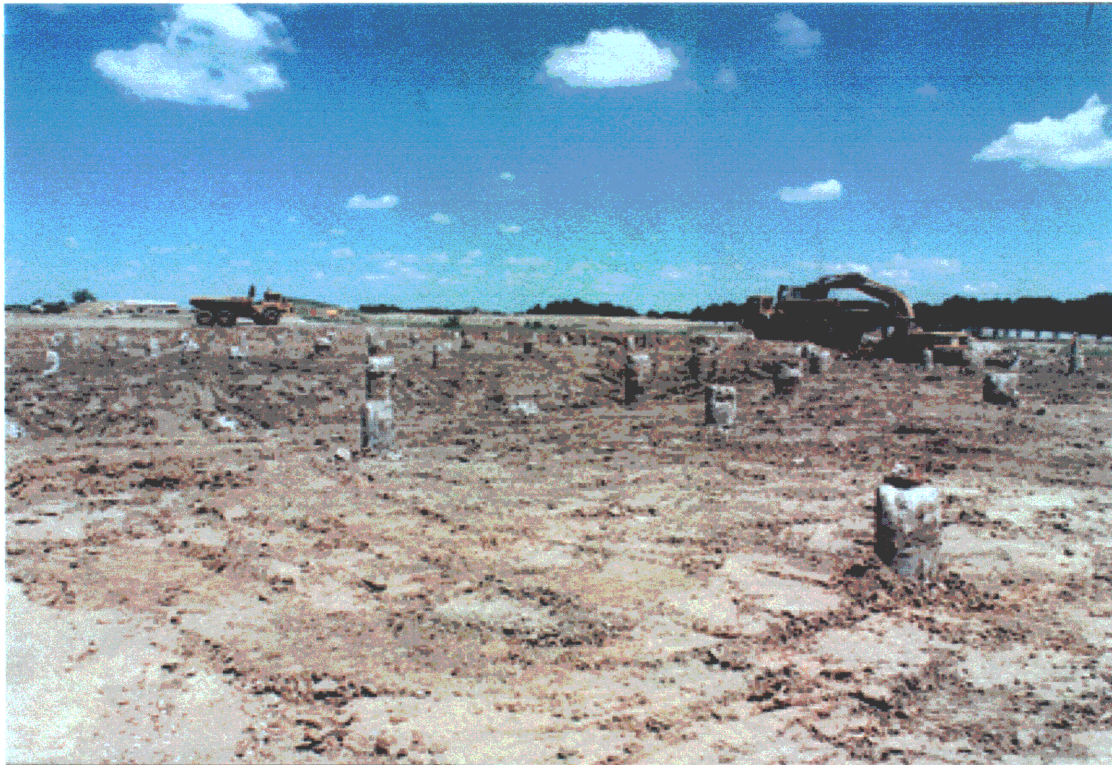
FOUNDATION REMOVAL PERFORMED UNDER WP420

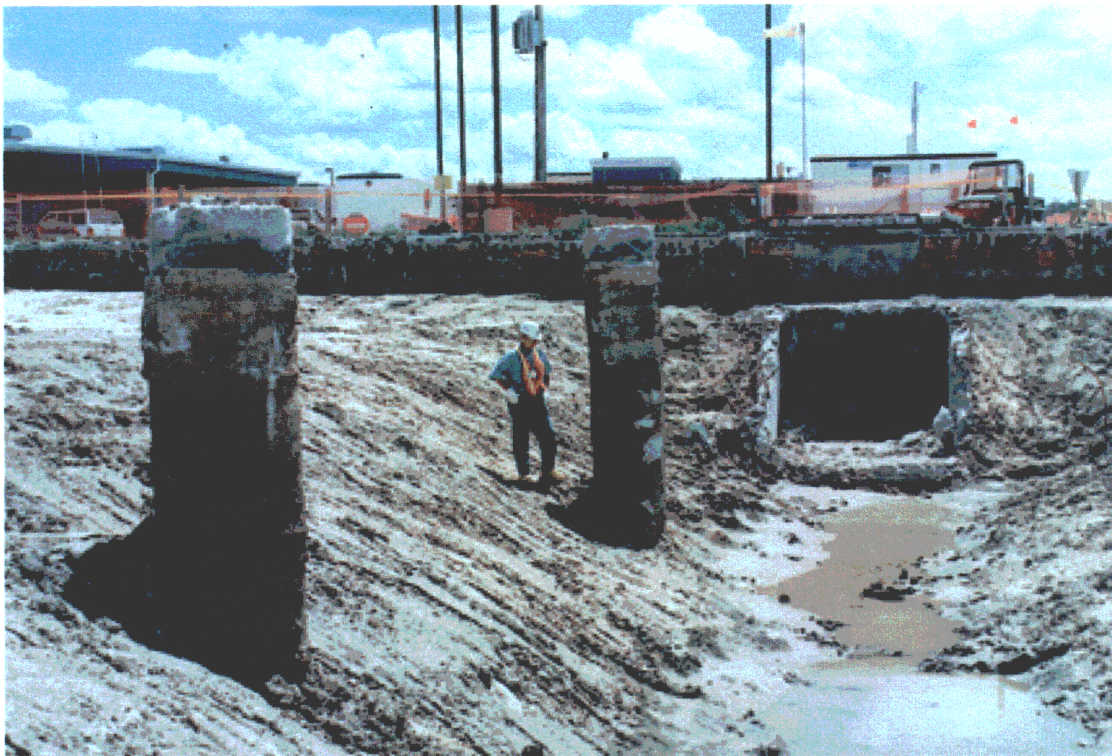
**FOUNDATION SUPPORTS EXPOSED DURING
WP420 EXCAVATIONS**

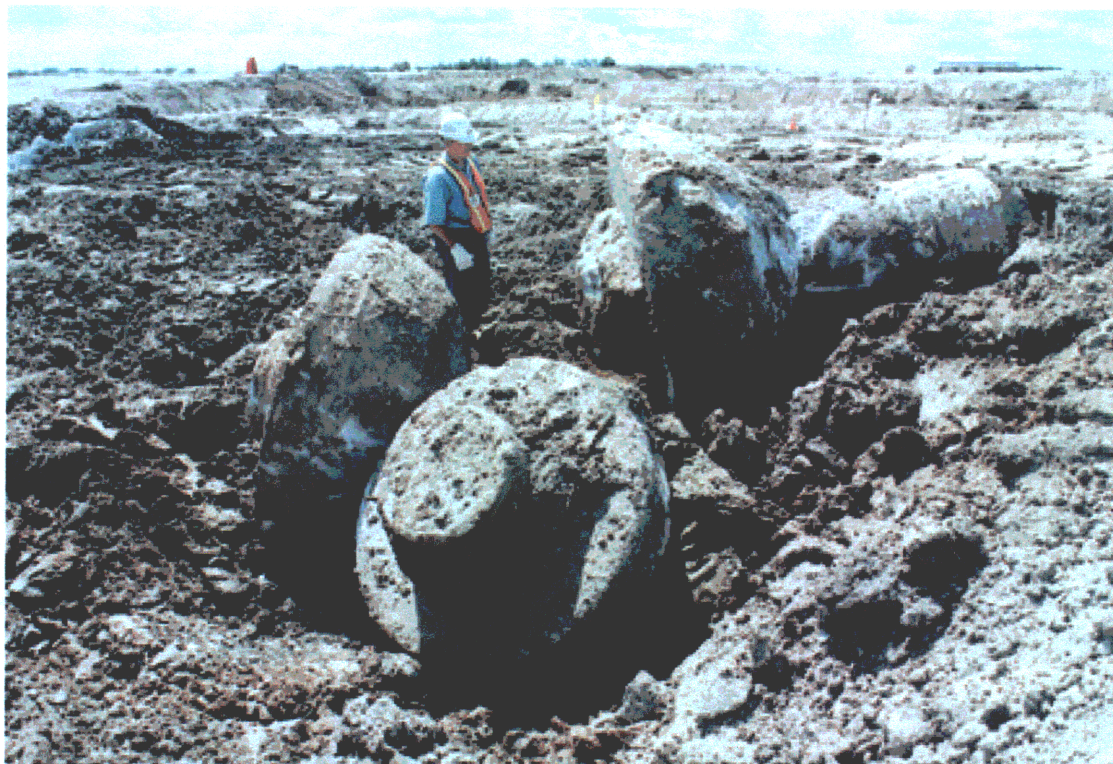
**FOUNDATION PIERS REMOVED DURING WP420
CONSTRUCTION ACTIVITIES**

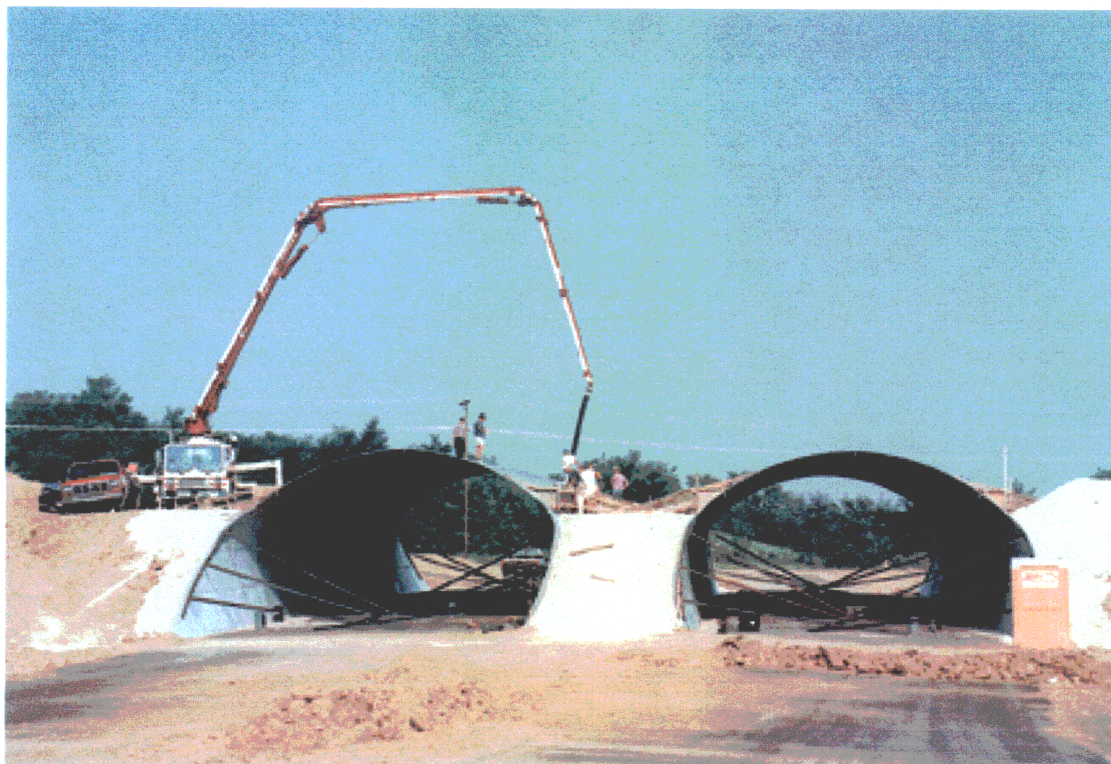
**BORROW HAUL ROAD TWIN TUNNELS BEING
INSTALLED BENEATH RELOCATED STATE HWY 94**

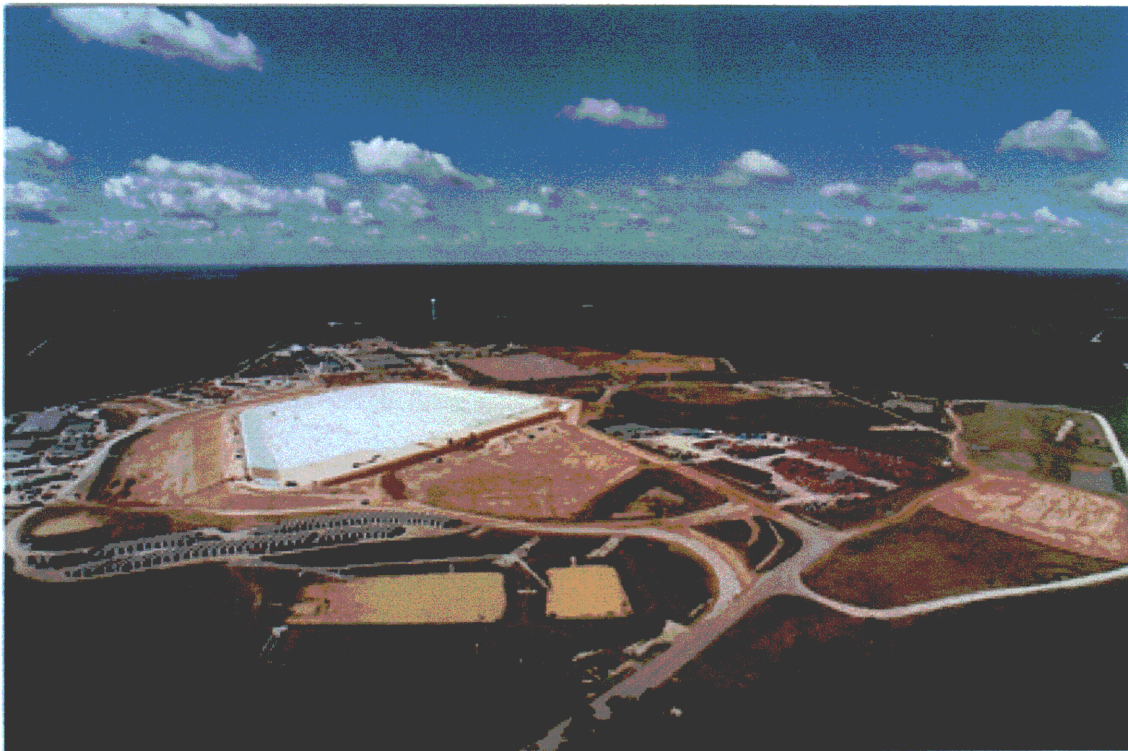
**CELL LINER SYSTEM INSTALLATION - PHASE 1 AREA
AUGUST 1997**

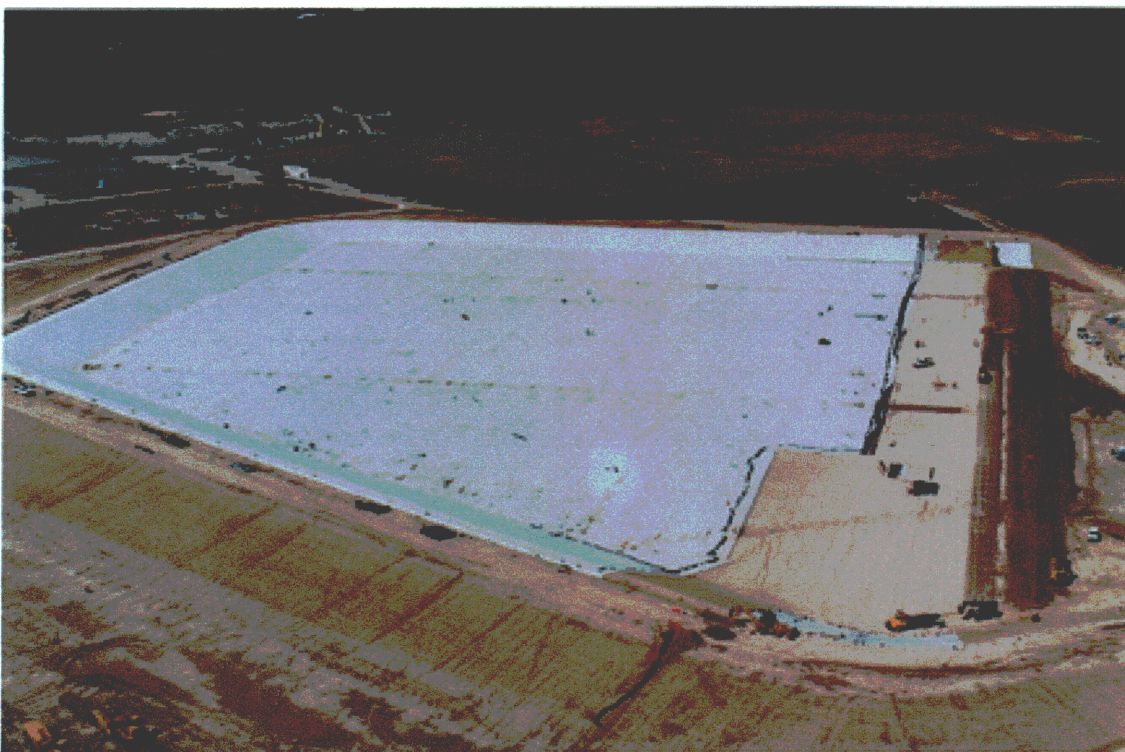
**CELL CCL TRIMMING AND LINER SYSTEM INSTALLATION
AUGUST 1997**
